Golden Lane Estate Walkabout

12/2/2020

GLERA

Description: Residents' walk about with Estate Staff and Common Councillors.

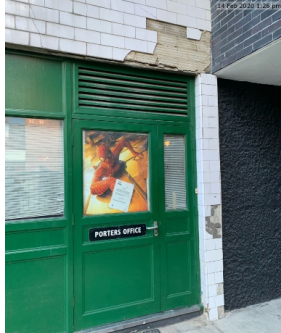
Cracked/Missing Tiling

Glazed tiles to base of podium cracked and spalling.

14 Feb 2020 at 1:15 pm
Can these be repaired using the same tiles as were used on Stanley Cohen?

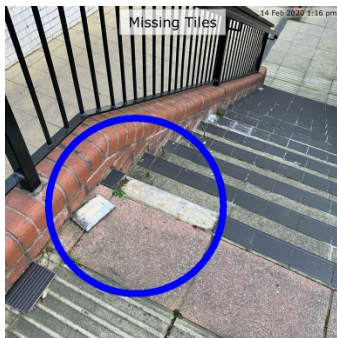
Tiled nosings displaced on steps

Lose/missing nosing tiles on steps down

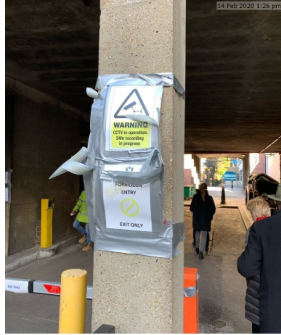
Signage to car park

Untidy temporary signage to car park.

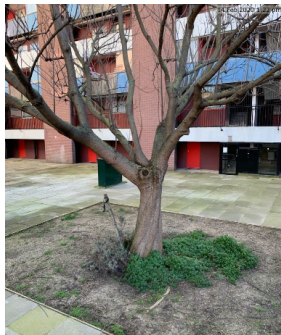
Water ponding/staining to Paving

Blocked drains causing water ponding outside Cuthbert Harowing House. Drain unblocking required urgently and

14 Feb 2020 at 1:24 pm
Part of general problem with lack of drain maintenance.

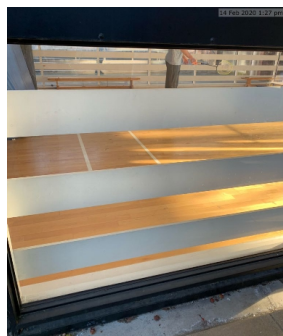
Flooring Lifting In Sports Hall (Again)

Flooring is becoming uneven and damage due to water ingress. Water ingress is caused by overflowing drains.

14 Feb 2020 at 1:28 pm
Drains need to be unblocked and maintenance contract put in place urgently across the estate.

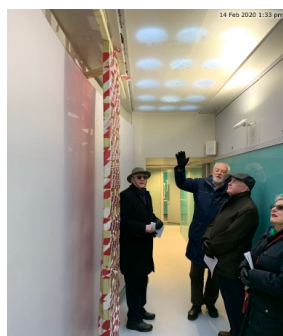
Spalling Concrete to Gym caused by water ingress

14 Feb 2020 at 1:35 pm
Part of issues with drainage and water ingress to podium.

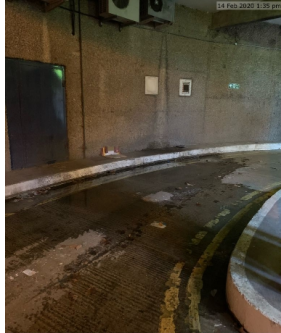
Blocked drain to car park ramp

Water ponding for several weeks at base of car park ramp. Cause by congealed fat in drains. Has been cleared, but problem not resolved.

14 Feb 2020 at 1:38 pm
Drains need to be cleared. Restaurants above are causing problem by pouring fat down the drains instead of paying to dispose of it. Estate Office will contact restaurants directly to ask them not to do this. Query why Residents should be paying for this damage?

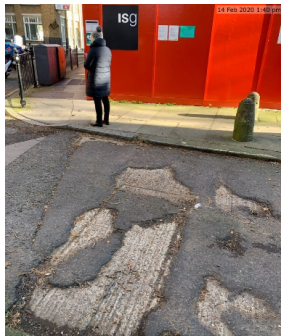
Uneven Road Surface at top of car park entry

Road surface at top of car park entry ramp is uneven and a trip hazard.

14 Feb 2020 at 1:41 pm
resurfacing required. Estate Office to identify who is

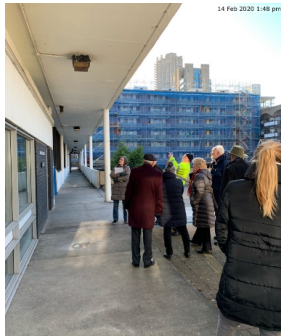
Light broken above entrance to Ralph Perring

Light is broken due to water ingress. Unsafe for people using Ralph Perring Centre.

14 Feb 2020 at 1:43 pm
Water ingress needs to be sealed and then light repaired/replaced.

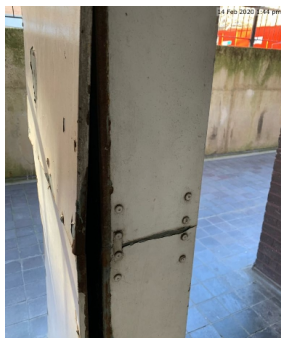
Electrical conduit casing loose

Metal casing to electrical conduit is loose and needs to be re-fixed

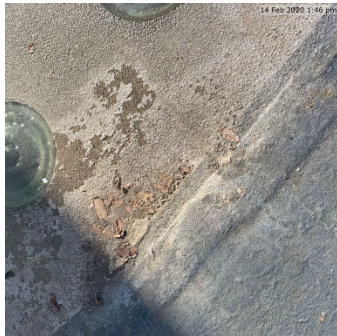
Water damage to concrete above gym

Water damage due to ponding water. Drains not cleared.

14 Feb 2020 at 1:48 pm
Drains and gullies blocked with leaf litter and debris. Need to be cleared and Maintenance contract urgently needed for drains

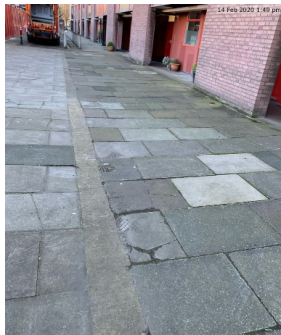
Paving Replacement Mismatch

Paving across the estate is being replaced with mid-matched (white) paving slabs.

14 Feb 2020 at 1:51 pm
Estate office stated that supply of spare slabs exhausted. Nigel SMith pointed out that policy was to get in stock of slabs and

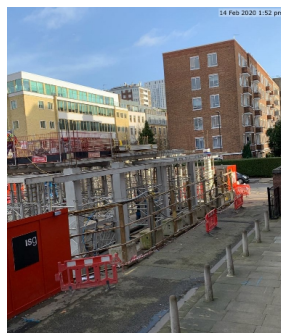
CoLPAI reducing fire access

The CoLPAI site have reduced the width of Basterfield Mews with temporary hoardings. GLERA have pointed out that this route is part of the fire access strategy for the Estate.

14 Feb 2020 at 1:55 pm
 Arrangement of hoarding and street bollards make access into Basterfield Mews very difficult - Rubbish lorry could not turn in without mounting pavement and using empty parking bays opposite. Estate Office to talk to CoLPAI and ensure access is maintained at all times.

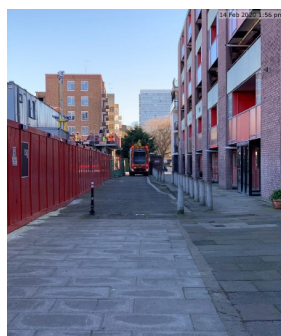
Grit on Basterfield Mews

GLERA reported that workers on roof of Basterfield House had brushed grit down into pavement.

14 Feb 2020 at 1:58 pm
 Basterfield Mews to be swept and workers advised not to let

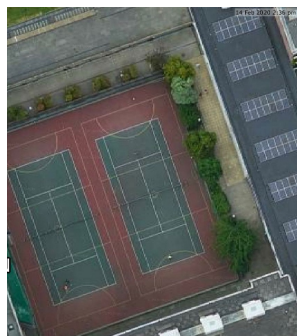
Tennis Courts

Water is ponding on tennis courts. Finish is becoming slippery and unsafe to use.

14 Feb 2020 at 2:38 pm
Courts need to be properly cleaned with specialist equipment.
Estate office to advise whose responsibility this is.
